HOME INSPECTION REPORT

XXX X. XXXXX Street, Anywhere, MI 44444

Inspection Date: 04/29/2011

Prepared by: Absolute Home Services, LLC
438 W. Seventh St.
Traverse City, MI 49684
231-929-4528 absolute@chartermi.net

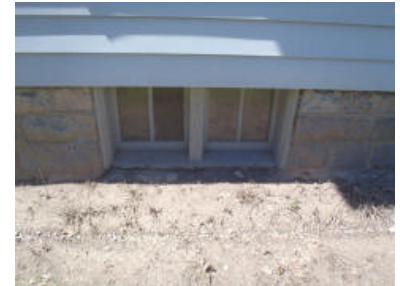
There are some areas around the building that have some flat or negative grade at east and west wall. We suggest pitching of soils away from foundation. Slope should fall away from the foundation at a minimum of 1/2 inch per foot and extend at least 10 feet away from the foundation. Grading is a bit close to basement windows-this may allow moisture to enter basement area during measurable rainfall. We will pay particular attention to this during the basement portion of the inspection.

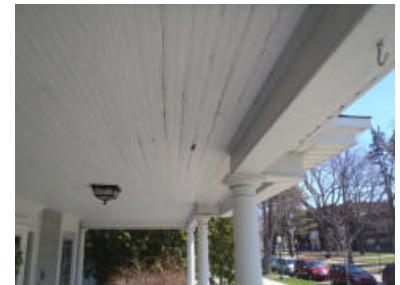
**ROOF CONDITION:**

Deflection noted, moisture (possibly from condensation - lack of ventilation) damage at soffit.
Possible ice damming.

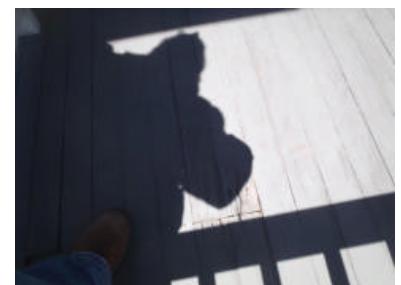
**SURFACE CONDITION:**

Moisture damage in few areas, decking is spongy in these areas.

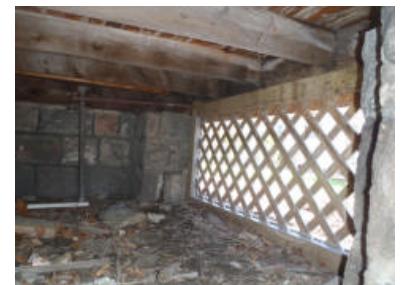
**OVERALL FRAMING CONDITION:**

Porch is underbuilt to today's standards however typical of era.
Recommend joist hangers be used to hold up decking floor joist.

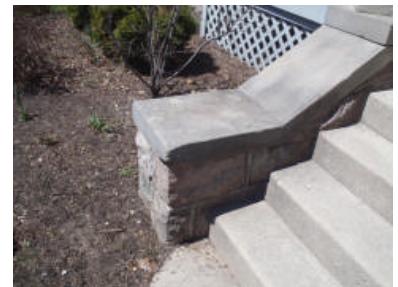
STAIRS/STEPS CONDITION:

Side blocks at stairs are loose and have cracked mortar/loose stones.

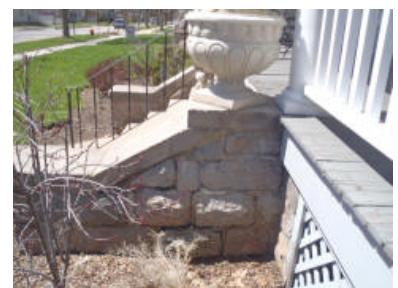
RAILING SYSTEM:

Iron railing is a bit loose.

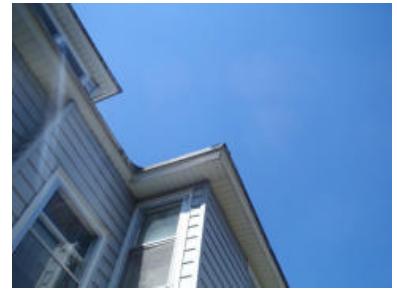
CONDITION: Evidence of ice damming noted. May be hidden damage in overhangs, attic, and wall area. However, they have been known to expand and move a bit during hot days. Poor or missing ventilation noted. Suggest installing soffit vents to ensure proper ventilation in attic areas and minimize ice damming.

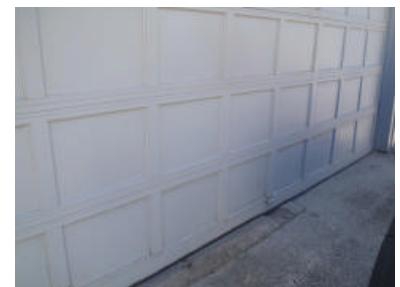
Moisture damage on both doors.

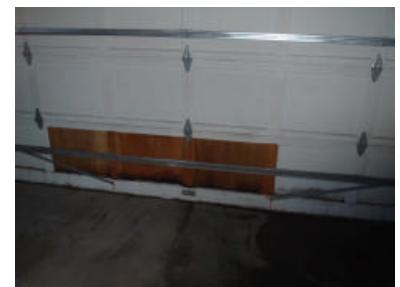
Repairs made to larger door.

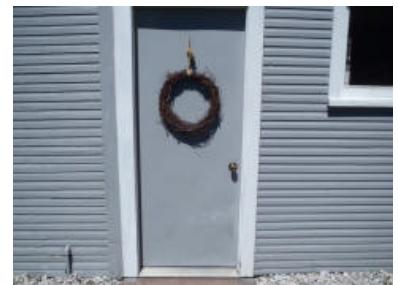
Condition: Door has never been painted -only primer on door panel and jambs. The jamb and brick mold on the door need caulking and painting to prevent exposure damage.

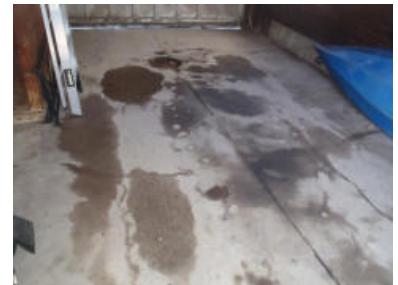
Floor Condition:

Large cracks noted.

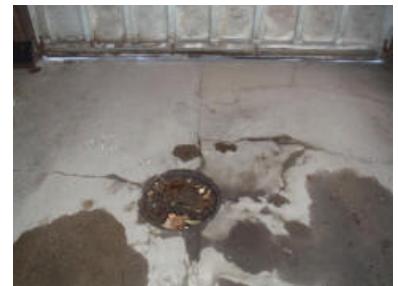
Moisture noted on floor of garage.

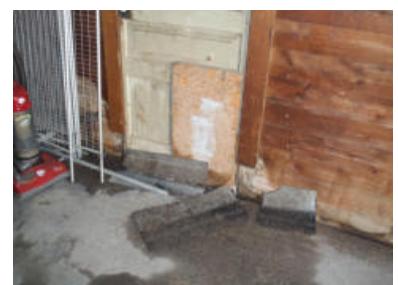
Garage Interior Walls Condition:

Wood walls-moisture stains noted at back wall and where old door is blocked off.

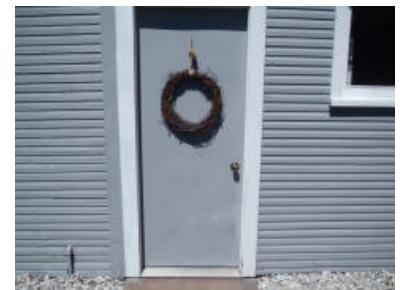
Wood siding- siding is resting in grade.

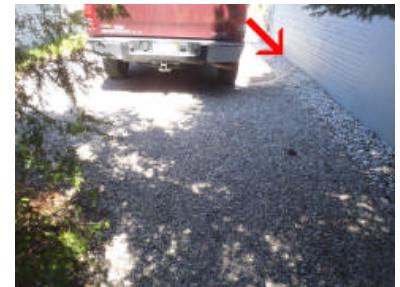
Exterior walls are bulging out and are bowed.

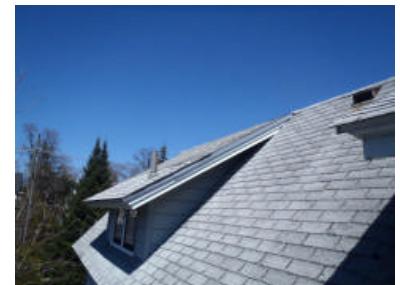
Deflection noted at roof plane. This may be due to undersized rafters.

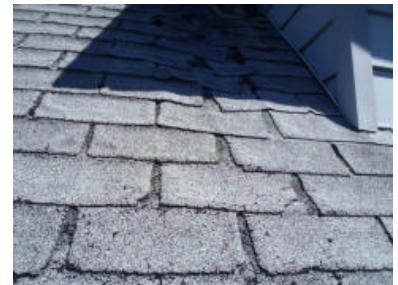
Margins between tabs are spreading indicating the shingles are at the end of their life.

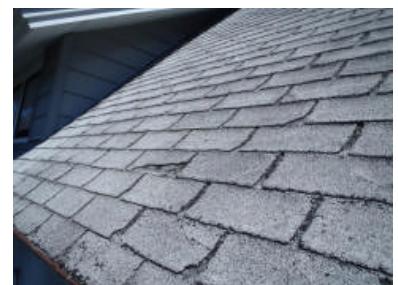
Tabs at eaves are heavily worn.

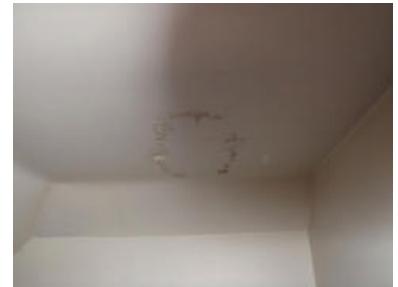
There is water staining on the underside of the roof at plaster. The stains are not currently wet nor do they have an elevated moisture content.

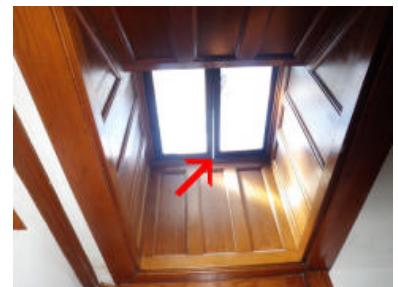
Poor conditions exist at the old "skylight". This area will need to be redone when the roof is being installed. Currently there are openings between the glass panes on the sashes in the unit.

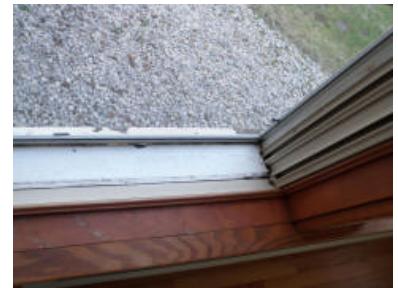
Exterior sills need to be painted. Showing signs of rot.

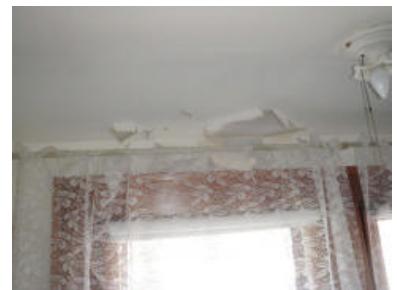
Action Necessary - There is a condition in the ceiling of this room that needs to be repaired.
 Previous Leak - There are signs of a previous water leak in the ceiling in this room. It does not appear to be an active leak.

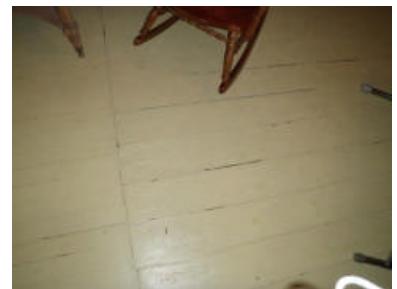
Marginal condition. Hump in floor noted. Gaps noted.

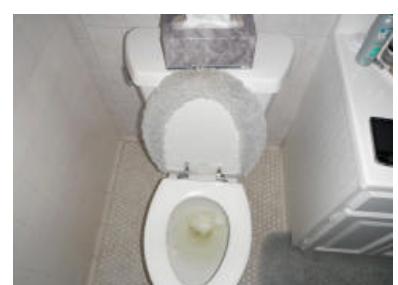
Toilet is clogged. Will not flush.

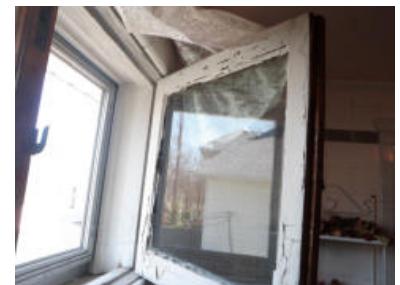
WINDOWS: Poor condition, single pane, rot noted. Recommend replacing.

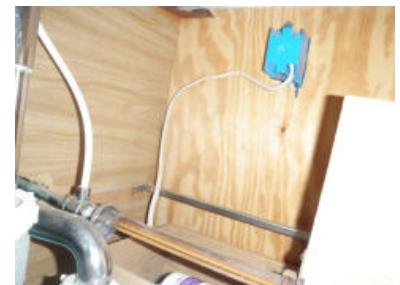
Unprotected wiring under sink noted.

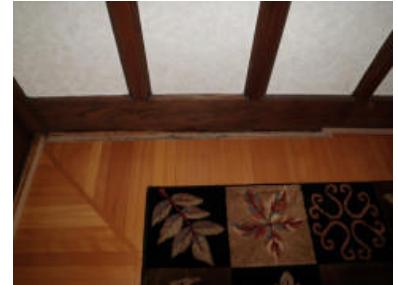
Trim pieces are missing and/or loose.

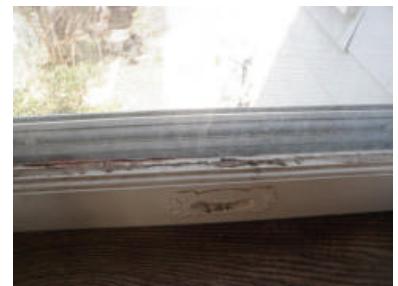
Small crack in glass noted.

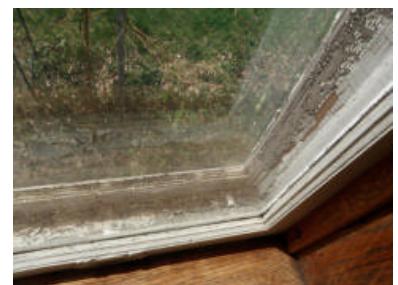
Rotting noted, recommend replacing.

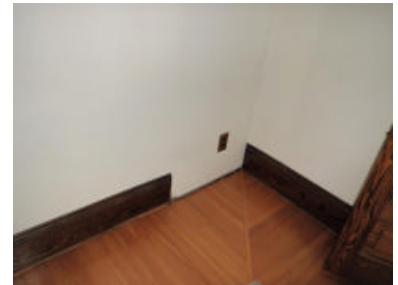
Drywall over plaster without removing trim. Section of trim missing at corner.

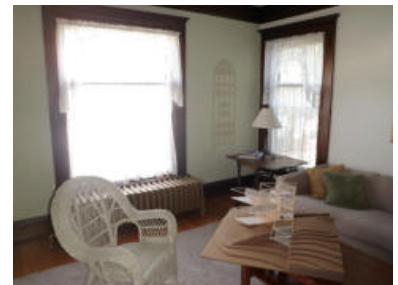
Single pane window(s)-these are typically very inefficient units and require a storm window to help with heat loss and drafts. A window unit in this room was found to operate hard. This may simply need adjustment or could require replacement.

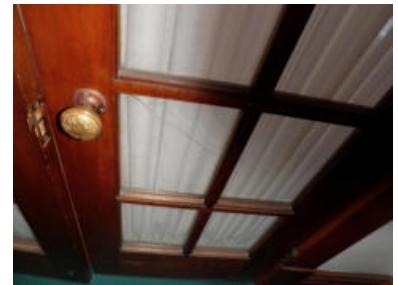
Door: French doors - rub/close hard. Two panes have broken glass. Glass not tempered.

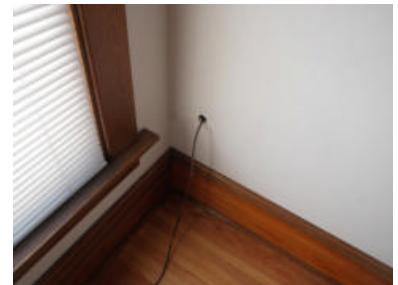
Closet: Poor electrical practices noted-extension cord run through the wall.

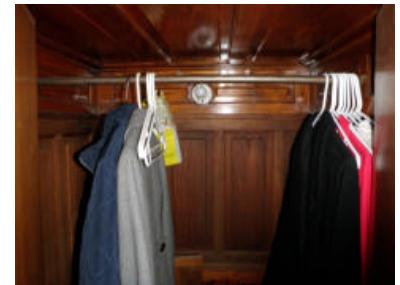
Under steps -exposed bulb light fixture in back of closet.

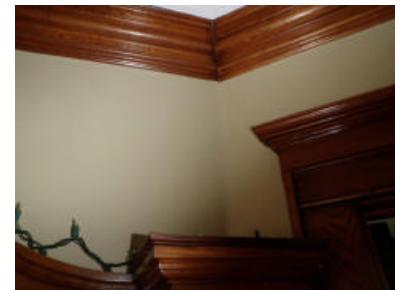
Plaster repairs noted near fireplace and by door.

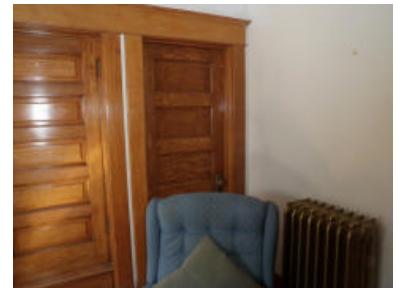
Walls: Many plaster cracks noted-some appear to have been from prior moisture entry.

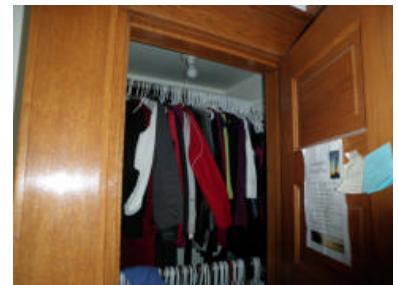
Door: Door rubs on jamb or strike plate and may need some adjustments to close easily and latch properly. The door does not latch properly when closed in a normal fashion. This typically requires some adjustments to either the door or hardware or both.

Attention Needed - The closet doors or fixtures need some adjustment or repair. The latch or strike plate needs to be adjusted so that the door will latch correctly.

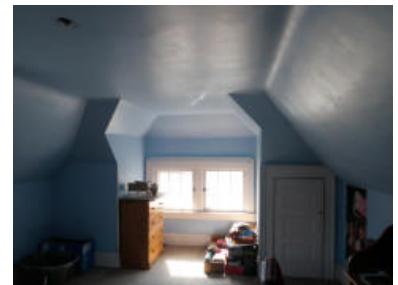
Door: The door does not latch properly when closed in a normal fashion. This typically requires some adjustments to either the door or hardware or both.
Damaged knob:

Closet: Knee wall closets -doors don't latch.

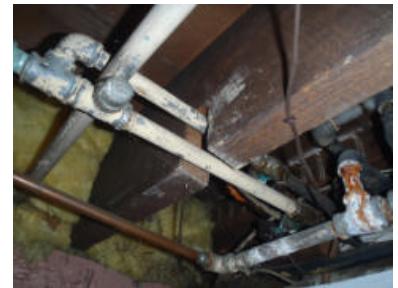
At least one floor joist has been notched - this jeopardizes the structural integrity of the joist and is not recommended.

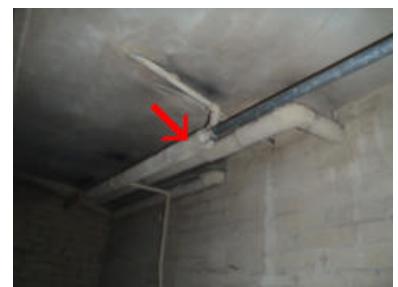
Asbestos pipe insulation noted
Mold/mildew noted on ceiling bead board.
Cracked glass in basement windows.

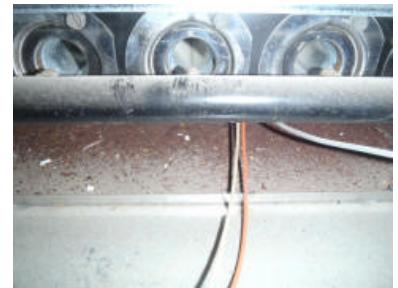
Burner Flame(s) appear typical and no signs of immediate concerns. Soot/Charring noted in burn chamber. Unit may need tuning up.

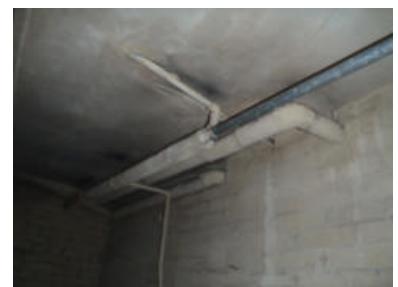
Possible asbestos containing material - Pipe wrap.

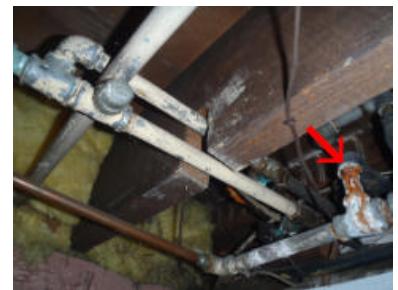
Location of Leak in Supply Line: Above stairway on galvanized line.

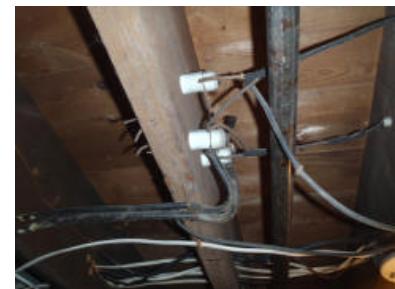
The house has existing knob and tube wiring in use. Due to its age and increased circuit needs, it is suggested that consideration be given to upgrading the system to current standards. Estimates from a qualified licensed electrician would be needed. Old cloth wiring also noted-this is a two wire system that does not have a ground for each device.

Several live knob and tube circuits noted - recommend contracting an electrician to get an estimate to update the wiring.

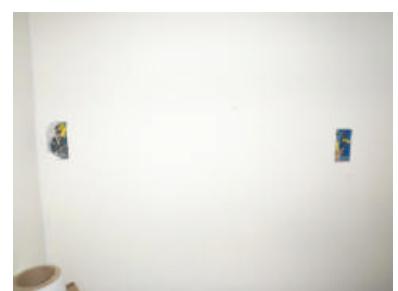
2-prong ungrounded outlets-suggest upgrading to grounded outlets near metal appliances and GFCI protected outlets near (within six feet) water. The noted outlet has the hot and neutral wires reversed.

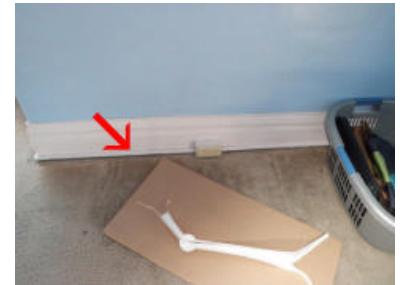
Wire mold hiding wires to grounded outlets. This indicates do-it-yourself wiring.

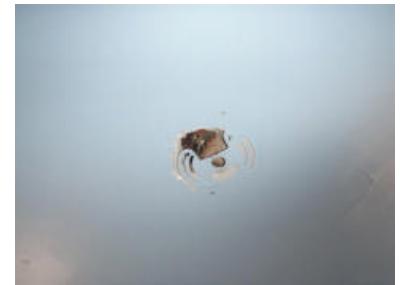
No switch or fixture - missing cover noted.
