# HOME INSPECTION REPORT

1234 XYZ Drive, Anywhere, MI 44444

Inspection Date: 05/26/2010

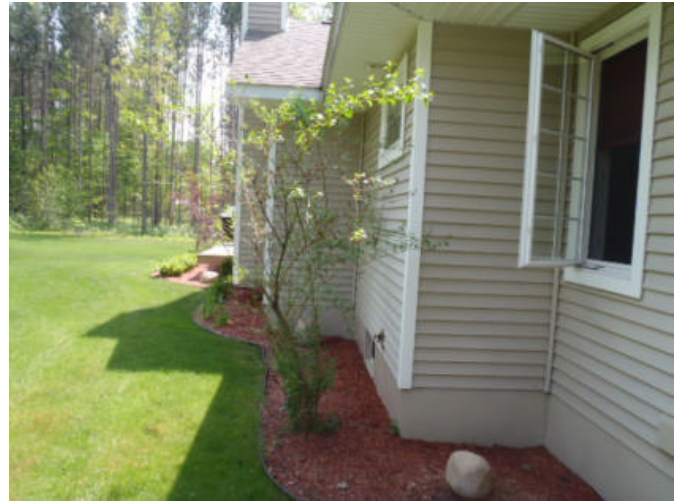
Trim plants and shrubs away from structure.

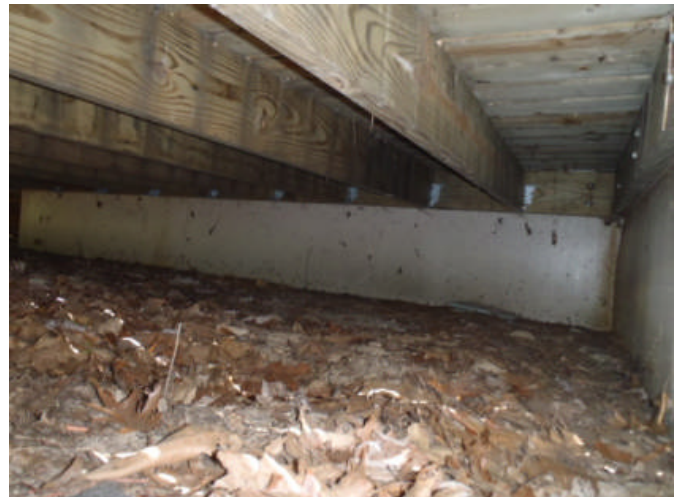
Flashing is missing between the wall and decking. It is recommended that flashing be used to keep water from backing up into house.

Signs of UV and/or water damage are noted, due to missing or improper maintenance procedures. Raised grain, splitting, cracking, warping, and cupping are all signs of UV/water damage and are prevented by maintaining

a proper exterior finish on all wood components. It is recommended that the deck surface and all exposed wood components be stained/sealed to prevent water and UV damage and extend the life of the wood components. A good, high quality preservative should last a minimum of two years.

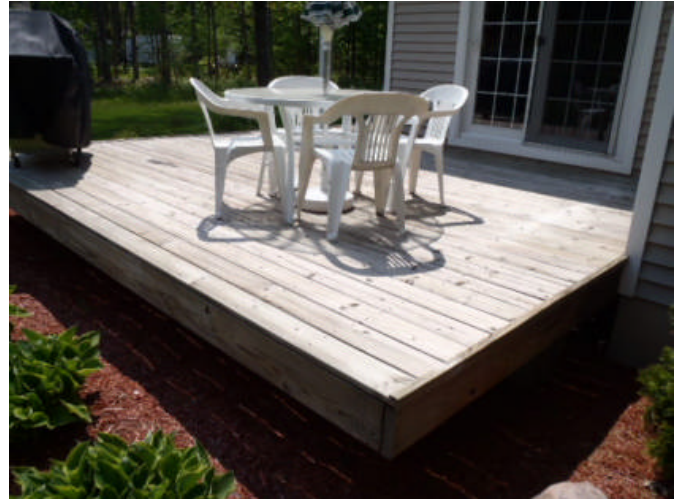
Floor joists are cantilevered too far at outside edge-currently the deck is sagging at the outside edge/corner. We suggest placing an additional post and beam set at the outside edge of the deck to take the bounce and deflection out.

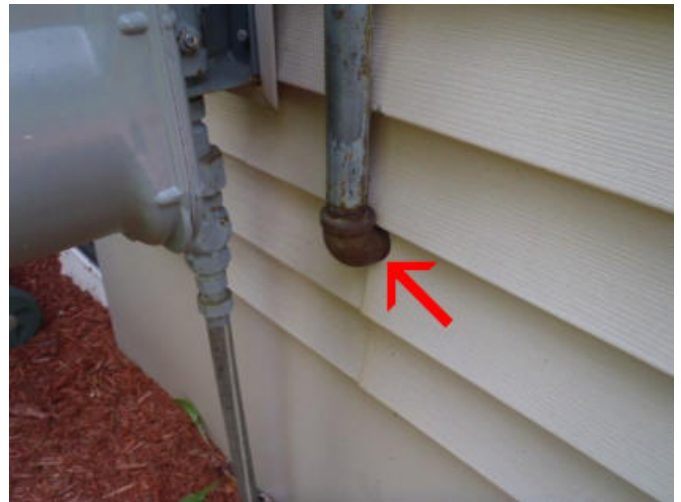
**Attention Needed** - A few spots around the structure were noted that need to be caulked. Many of the pipe penetrations need to be caulked.

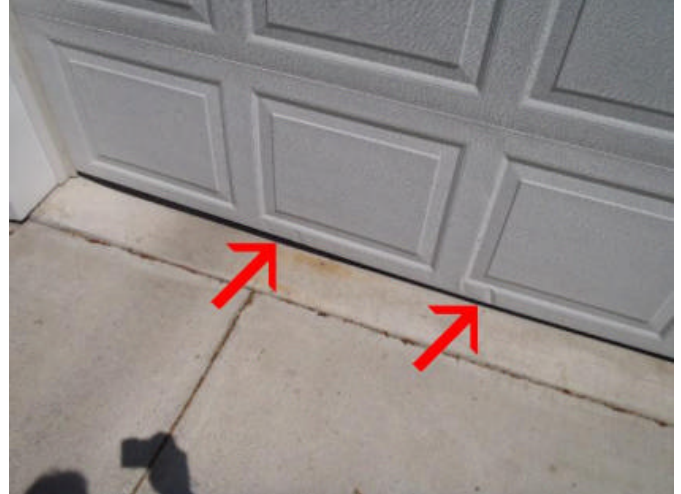
Some dents noted at the bottom section.

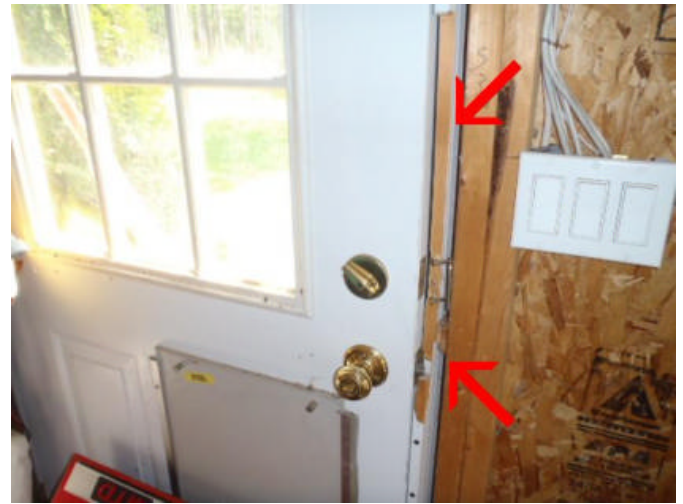
Steel door has damaged jamb from forced entry.

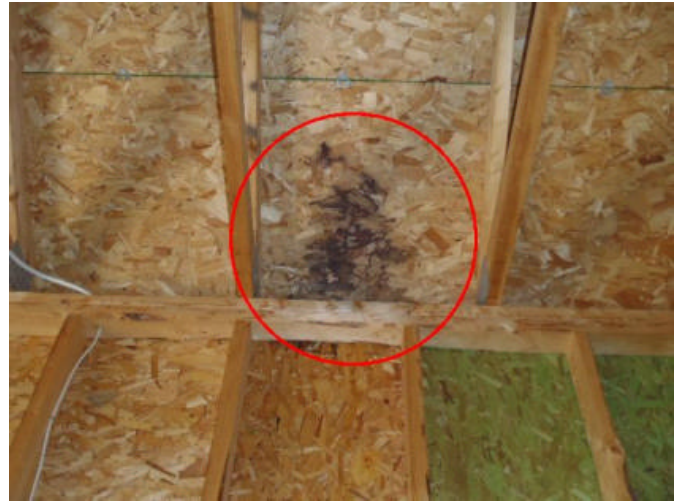
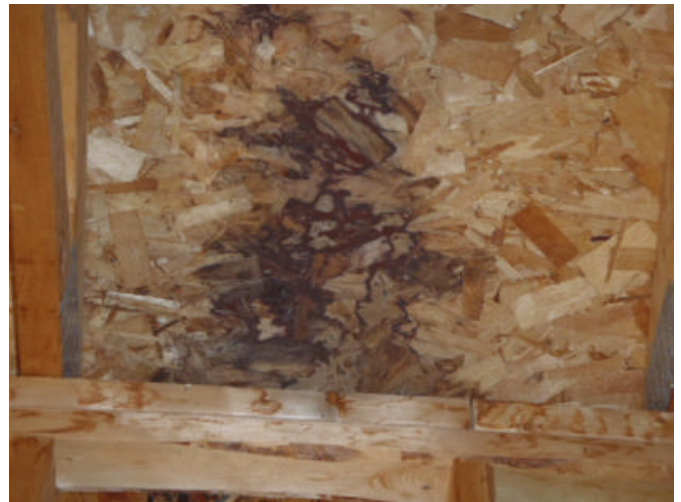
Staining noted at end of valley - older stain possibly ice damming.

We suggest inquiring with the owner as to the timing and duration of the stain-there does appear to have been some repair or maintenance at the valley in an attempt to address this issue.

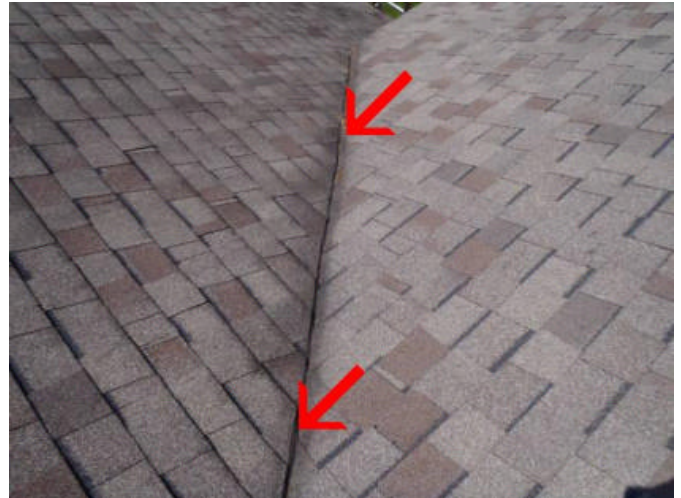
There has been some rubber/tar added in one valley-this is the valley over the garage and there is a moisture stain below near the eave. We suggest inquiring about valley flashing repair and stain with the current owner.

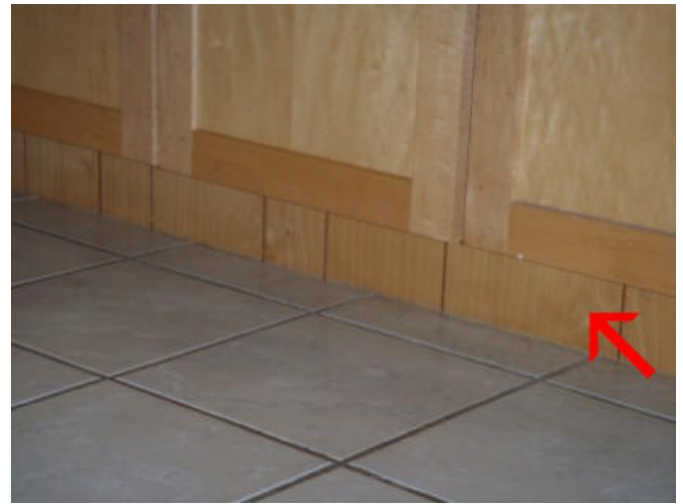
Some cabinet doors appear to need adjustment or may have become warped. No fillers against walls/pantry-causes doors to rub when operated. Paneling used as a toe kick.

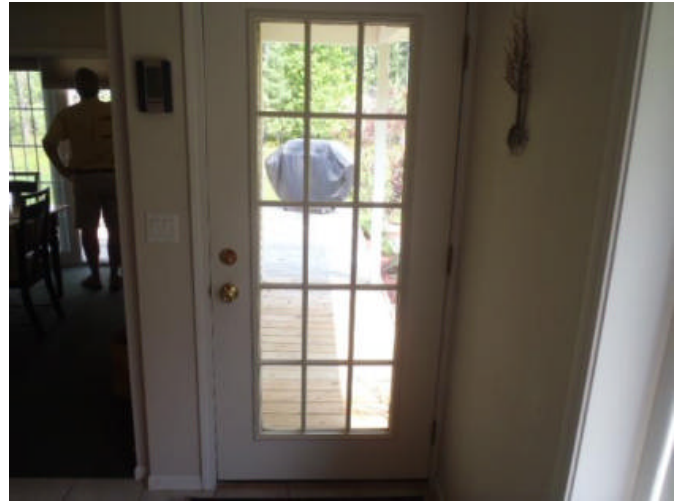
Condition, Door rubs at jamb a bit. Adjustments needed.

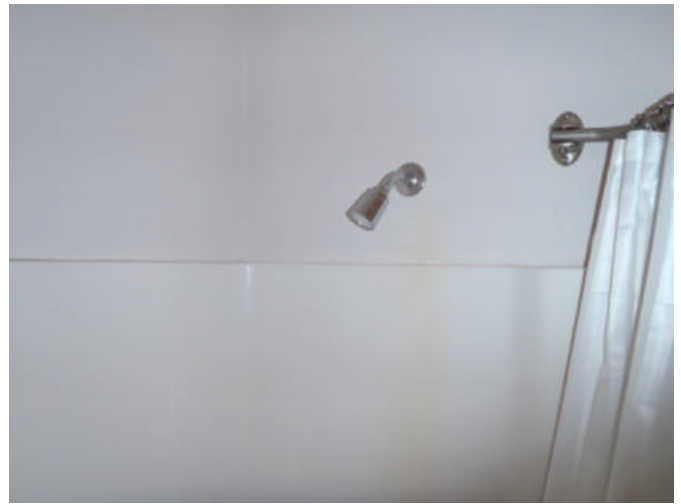
Minor moisture damage  
above tub.

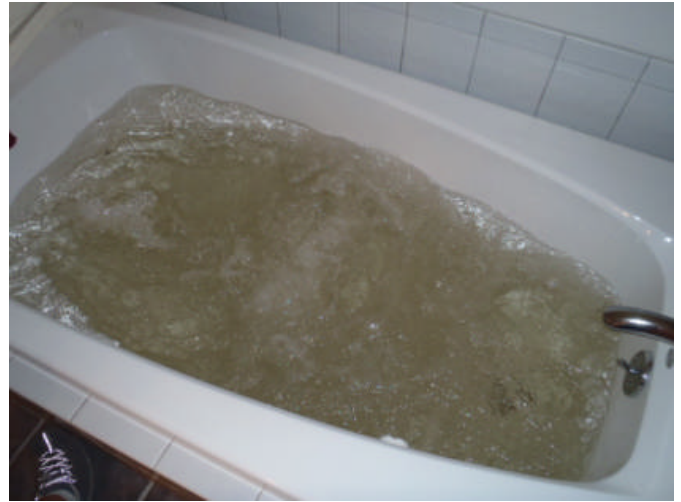
There is a spa tub installed. The tub was filled with water and the jets activated to observe for proper action. The tub appeared to function properly. However, one jet did not function.

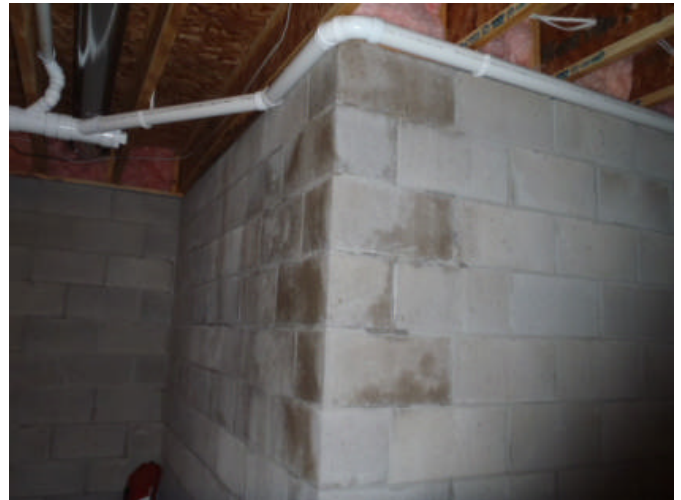
Minor settlement cracks noted, not significant at this time,  
Staining was observed:  
Evidence of present water penetration is noted- Seen at deck area.

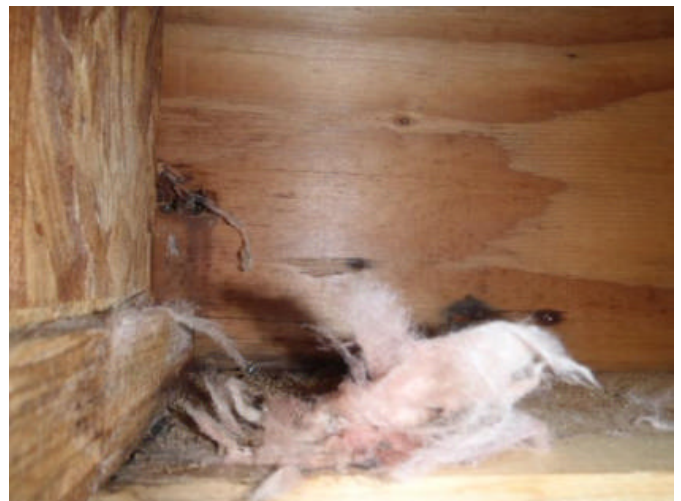
Moisture damage where deck is attached to house. Moisture has been getting into the rim joist area for quite a while and it is deteriorating the wood at both band joist areas where the deck attaches to the house. Carpenter ants witnessed at the rotted rim joist. Suggest contacting a pest control specialist and licensed builder to further investigate and correct the issues.

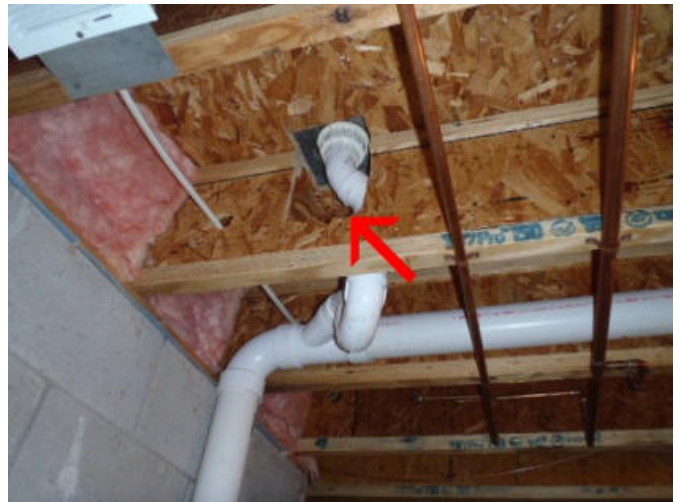
Joist has been notched out at master shower drain-top flange has been severed. Suggest reinforcement at this area.

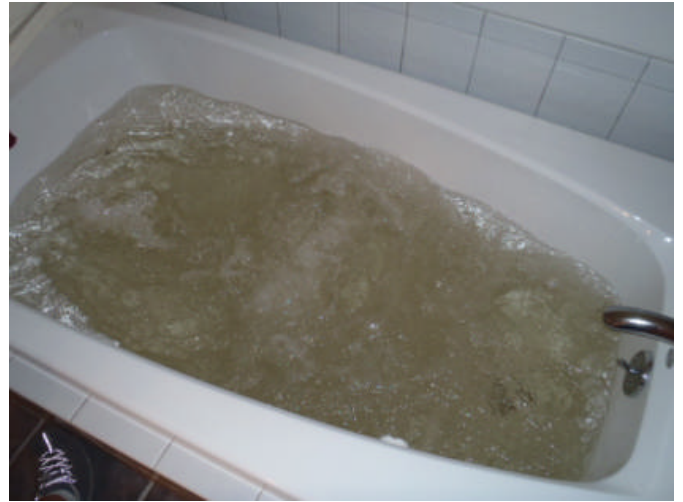
No odor noted during the inspection. However, there was quite a bit of sediment noted in the water when the tubs were filled and drained.

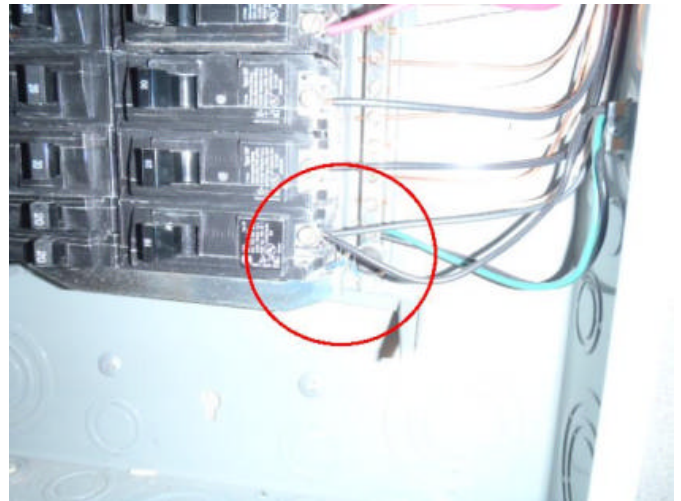
Multiple wires are connected to a single lug on a circuit breaker where only one wire should be connected.
