HOME INSPECTION REPORT

XXX X. XXXXX Street, Anywhere, MI 44444

Inspection Date: 04/29/2011

Prepared by: Absolute Home Services, LLC
438 W. Seventh St.
Traverse City, MI 49684
231-929-4528 absolute@chartermi.net

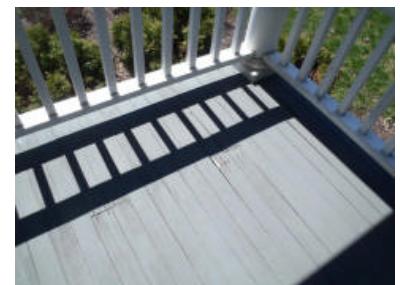
Moisture damage in few areas, decking is spongy in these areas.

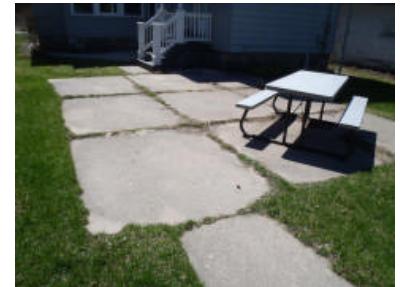
CONDITION: Pads have settled a bit in some areas and some overgrowth/vegetation noted.

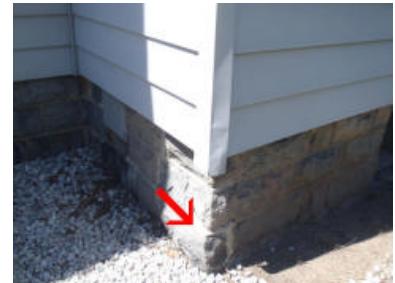
Type of Foundation: stone/granite block
 Condition: Cracks and loose mortar noted at a few areas-recommend having a professional mason perform some tuck/pointing.

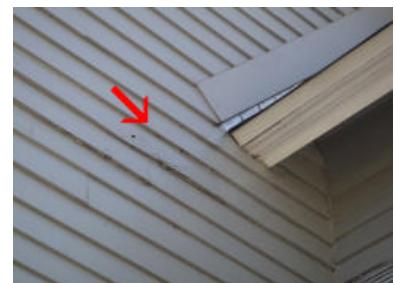
SIDING CONDITION:

Minor dents noted in aluminum siding
 Moisture damage noted on wood siding at rear from roof water.

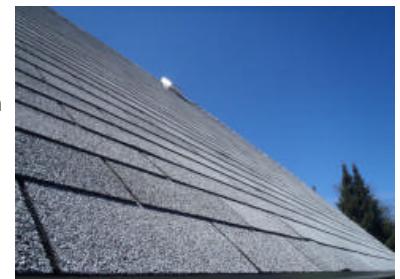
ROOF PLANE:

Deflection noted at roof plane. This may be due to undersized rafters.

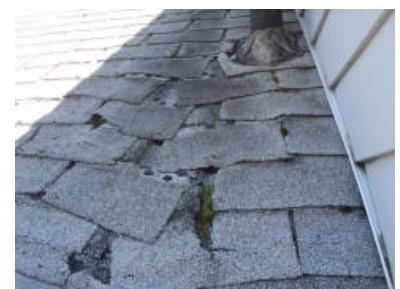
Shingles are at the end of their life on majority of roof.

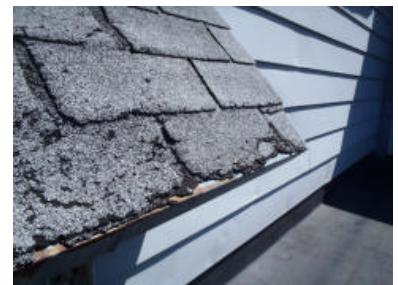
Torn tabs at the eaves indicate ice damming has occurred-this is very common at older homes.

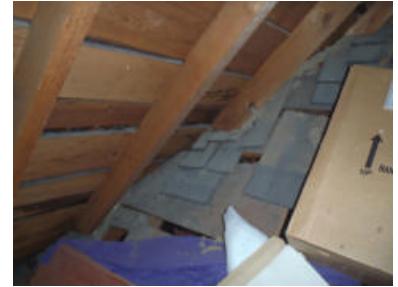
A 2 x 4 rafters system is present. This is undersized by today's standards. However, it is typical of the era of construction for the structure.

Suggest reinforcing the attic framing when the opportunity arises.

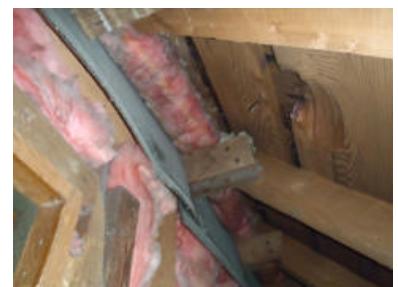
Soffit vents have been blocked with insulation. Suggest installing proper vents to keep air flowing and prevent mold/mildew growth. There is some ventilation installed; however, the existing venting does not allow adequate ventilation for the attic cavity. Action is necessary to correct this shortage of ventilation.

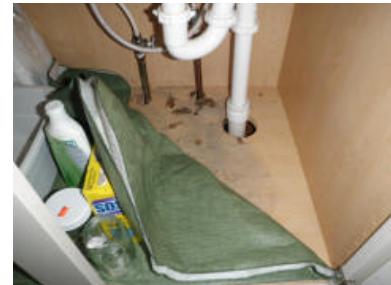
Evidence of a prior leak.

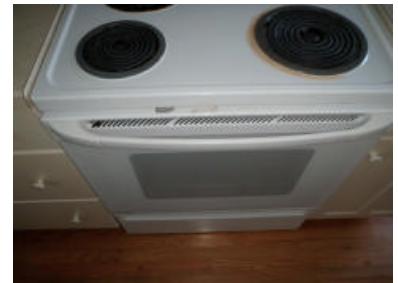
Loose handle noted.

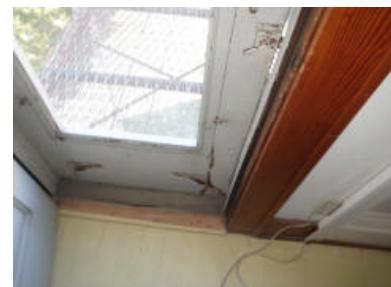
Linen Closet:

Action Necessary - Some portion of the closet door or interior fixtures needs repair or replacement.

Previous water damage noted, lath exposed, plaster repair needed.

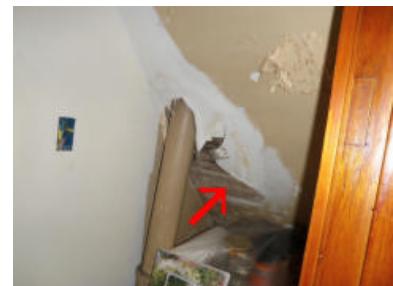
Walls:

Action Necessary - There is a condition in the wall sheeting that needs to be repaired. There is damage from a prior water leak. There does not appear to be a current leak. Repairs are needed.

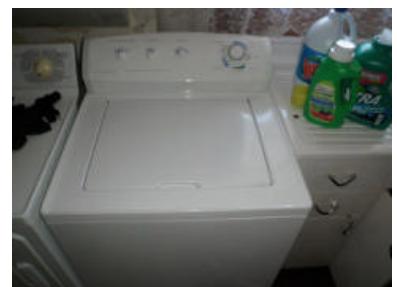
Clothes Washer:

The washer was not tested during the inspection due to clothes or belongings inside the unit.

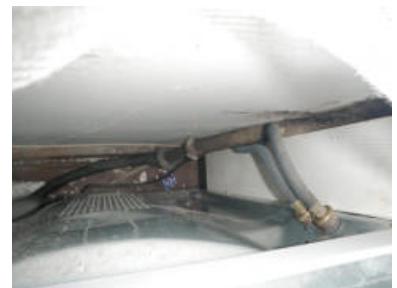
Washer Hookup:

There is only standard exposed plumbing hook ups installed-no recessed connection box installed.

Attention Needed - There is no trap on the drain line.

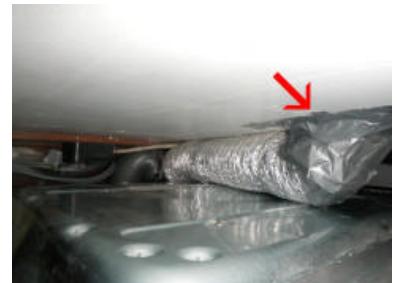
Dryer Ventilation:

Excessive duct tape used to hold the hose together.

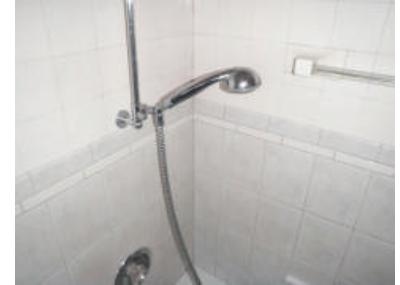
SHOWERHEAD CONDITION: There is a hand held unit present-hand held shower sprays tend to leak at the connections where the hose meets the fitting(s).

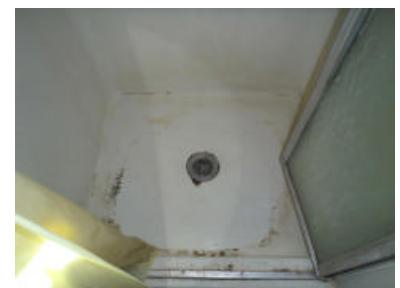
SHOWER ONLY TYPE:

Fiberglass one piece shower.

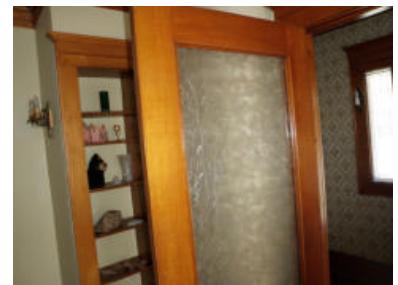
Door: Plastic lens with floral texture - this is not glass.

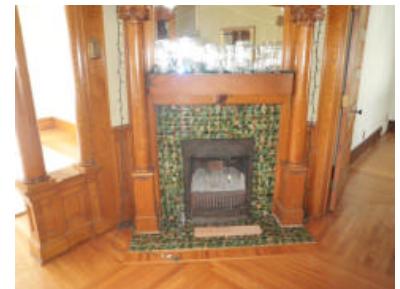
Heat Source Noted:

Only heat source in this room is the fireplace.

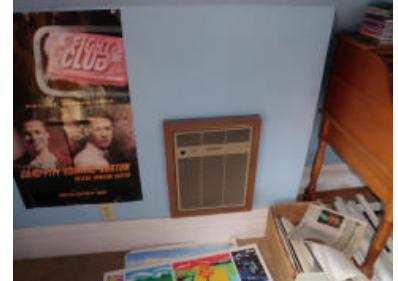
Walls: Marginal condition -many cracks and poor repairs noted.
Ceiling: Same as walls.
Floor: The floor covering material is carpet. Slopes and squeaks noted.
Ceiling Fan: No ceiling fan was noted in this room.
Windows: Single pane window(s)-these are typically very inefficient units and require a storm window to help with heat loss and drafts.
Heat Source Noted: An old electric wall heater installed - does not appear to be functional -missing knobs cannot test.

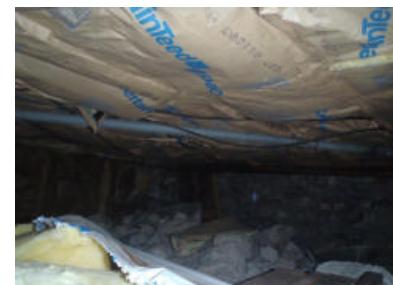
OTHER OBSERVATIONS:

Insulation in floor is installed backwards
Debris noted in crawlspace.

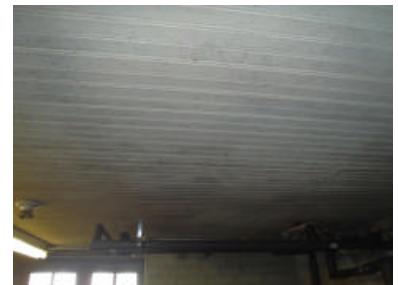
RIM JOIST

Not viewable due to wood ceiling.

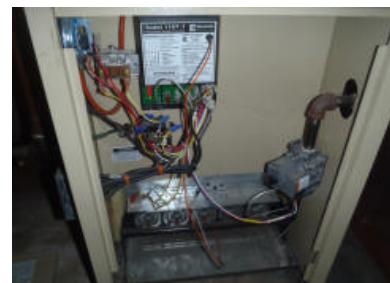
Burner Flame(s) appear typical and no signs of immediate concerns. Soot/Charring noted in burn chamber. Unit may need tuning up.

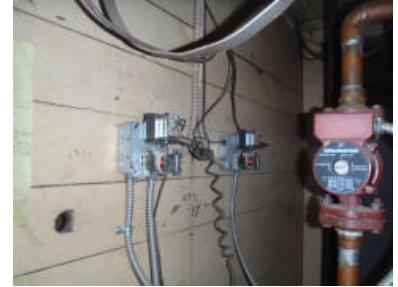
BOILER CIRCULATOR PUMP:

Appears Serviceable.

Inadequate-there was no dedicated intake air for this unit/area.

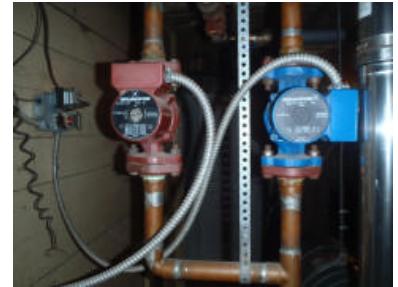
This appears to be a two zone system as identified by the two circulator pumps.

Possible asbestos containing material - Pipe wrap.

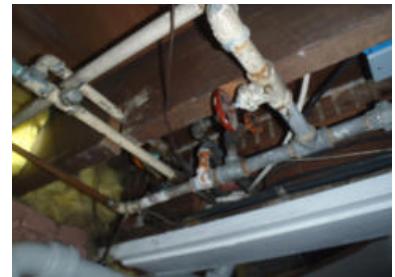
Interior Supply Piping Material:

The interior supply piping in the structure is predominantly galvanized. There is some older galvanized water piping installed. At some time the galvanized piping will need to be replaced. Over time, the rough walls of the galvanized piping collect mineral deposits from the water. As this accumulation grows, it reduces the interior water flow. Eventually, the flow is so restricted that replacement is needed. Some copper noted.

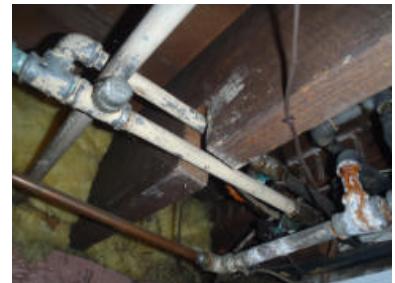
Leaks noted at above stairway on galvanized line. Copper/Galvanized piping contact is noted. Correction is recommend. A major loss of water volume occurs when using multiple fixtures.

Location of Leak in Supply Line: Above stairway on galvanized line.

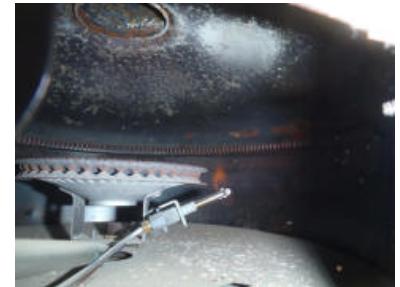
Serial Number: MB00-0077659-246.
Manufactured Date: 2000.
Tank Capacity: A 40 gallon water heater is installed.
Fuel Source for Water Heater: The water heater is gas-fired.
Exposed Water Heater Condition: Satisfactory - no signs of damage at exterior of the unit.
Firebox Condition
 The underside of the tank appears to be in normal condition in relation to its age.

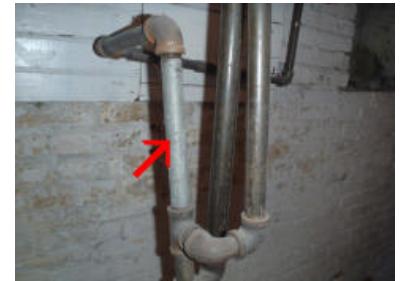
Natural Gas Lines and Meter

ADDITIONAL PLUMBING ITEMS: Galvanized gas line section noted-this is not recommended for gas line.
 Unsupported gas lines noted.

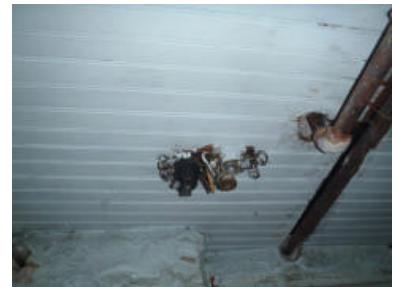
Action Necessary - It is recommended that some portions of the visible wiring be reinstalled or secured. A safety hazard may exist. Services of a qualified licensed

electrician are needed.

Several live knob and tube circuits noted - recommend contracting an electrician to get an estimate to update the wiring.

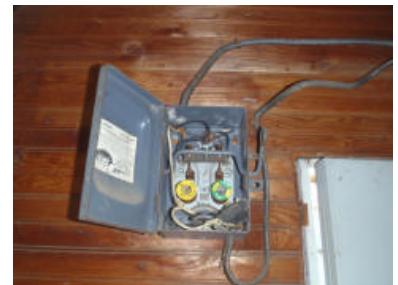
GARAGE:

Knob and tube wiring
 Bus fuse panel (30 amp fuses)
 Unsecured and unprotected wiring noted.
 Recommend having an electrician upgrade the electrical system.

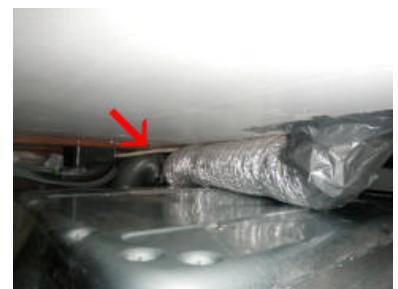
There is an unprotected wire behind washer/dryer.
